BCRSD PRAIRIE MEADOWS SSES TECHNICAL MEMORANDUM

Boone County Regional Sewer District
February 2024
McClure Project No. 2023001832-000

BCRSD Prairie Meadows SSES Technical Memorandum

McClure Project No. 2023001832-000

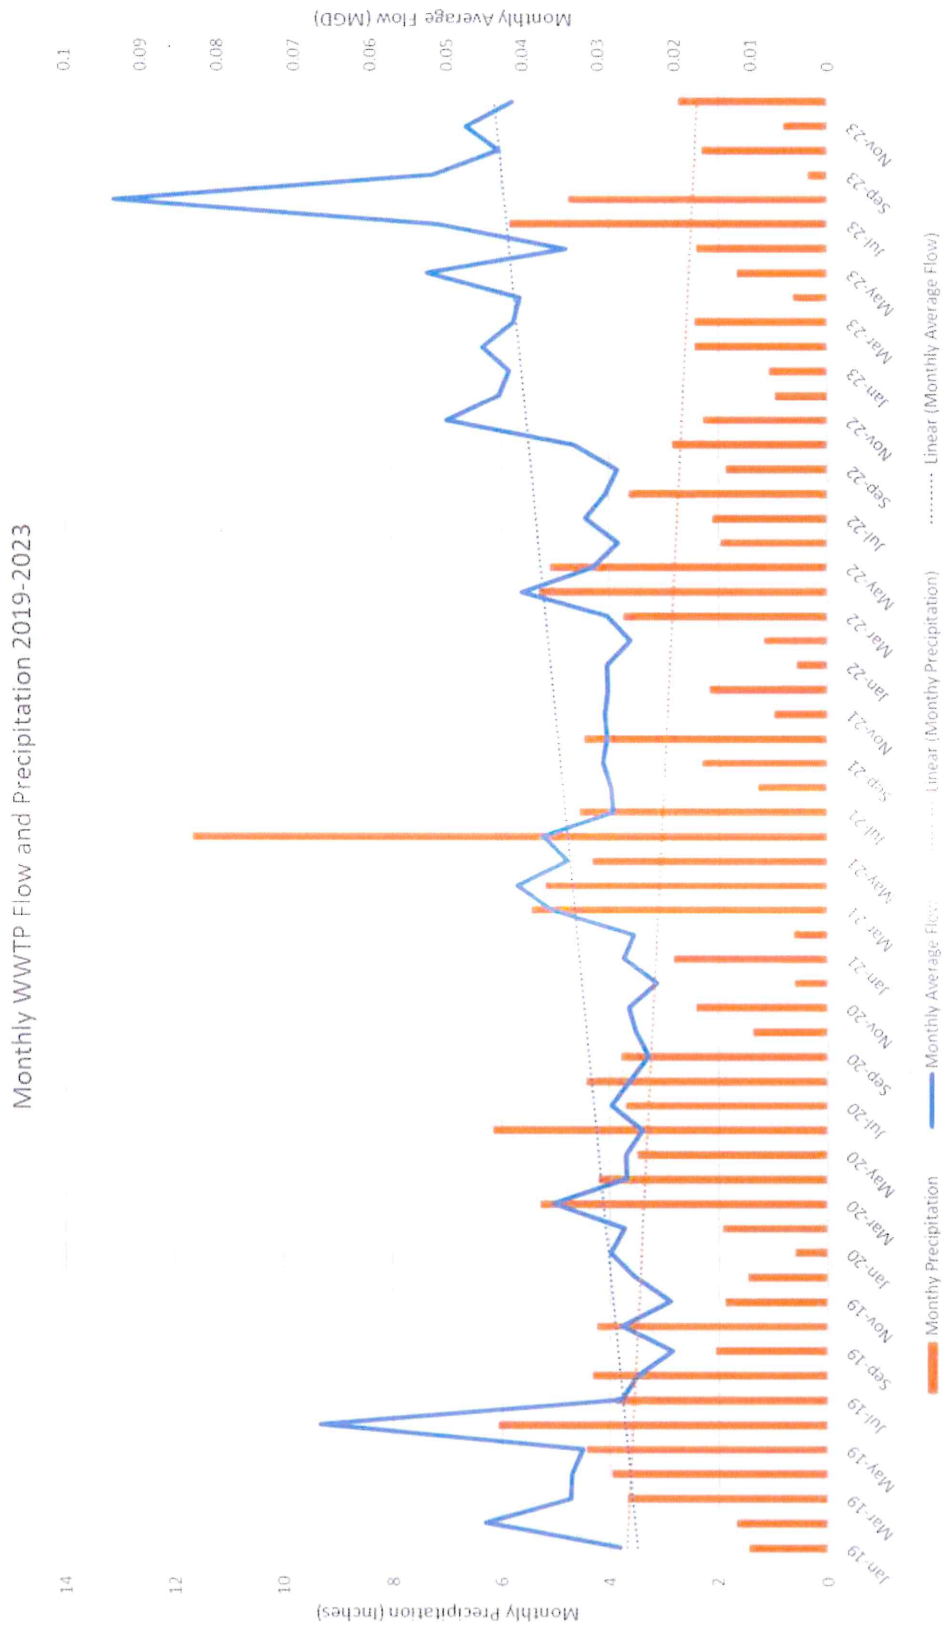
Exhibit 3.1: Monthly WWTP Flow and Precipitation Trend 2019-2023

As seen in Table 3.1, the yearly average effluent flow has generally increased from 0.0283 MGD in 2019 to 0.0493 MGD in 2023. For comparison with the effluent flow data, precipitation data was gathered from the Bradford Research and Extension Center weather station available through the University of Missouri Extension – Missouri Historical Agricultural Weather Database. The Bradford Research and Extension Center is approximately 3.8 miles east of the WWTP. Exhibit 3.1 illustrates the monthly average effluent flow from the WWTP compared to the total monthly precipitation. As seen by the linear projections in the graph, annual precipitation amounts generally decreased over the course of the five-year period while the average effluent flow trend increased.

As seen in the table, the peaking factors for 2019 to 2022 are all within 3.2 to 4.3 indicating minimal I/I impact on the collection system. However, in 2023 the peaking factor increased significantly to 12.4. There were no known new connections in 2023 to account for the increase in flow. In general, 2023 was a dry year with much of Boone County experiencing drought conditions. July and August were the wettest months of 2023 with recorded rainfall of totals of 5.84 inches and 4.77 inches respectively. The MWW of 0.382 MGD occurred on August 2, 2023. The Bradford Research and Extension Center weather station recorded a 1.13-inch rainfall on the same day. Additionally, BCRSD staff reported a manhole ahead of the influent pump station overflowed in late July 2023 as the influent pump station could not handle the increased peak flows. The spike in AWW and MWW flow observed in 2023 indicates a potentially severe defect or increased number of I/I pathways developed in 2023.
